ALERT

Alert No. 0002

SWIVEL HOIST RINGS

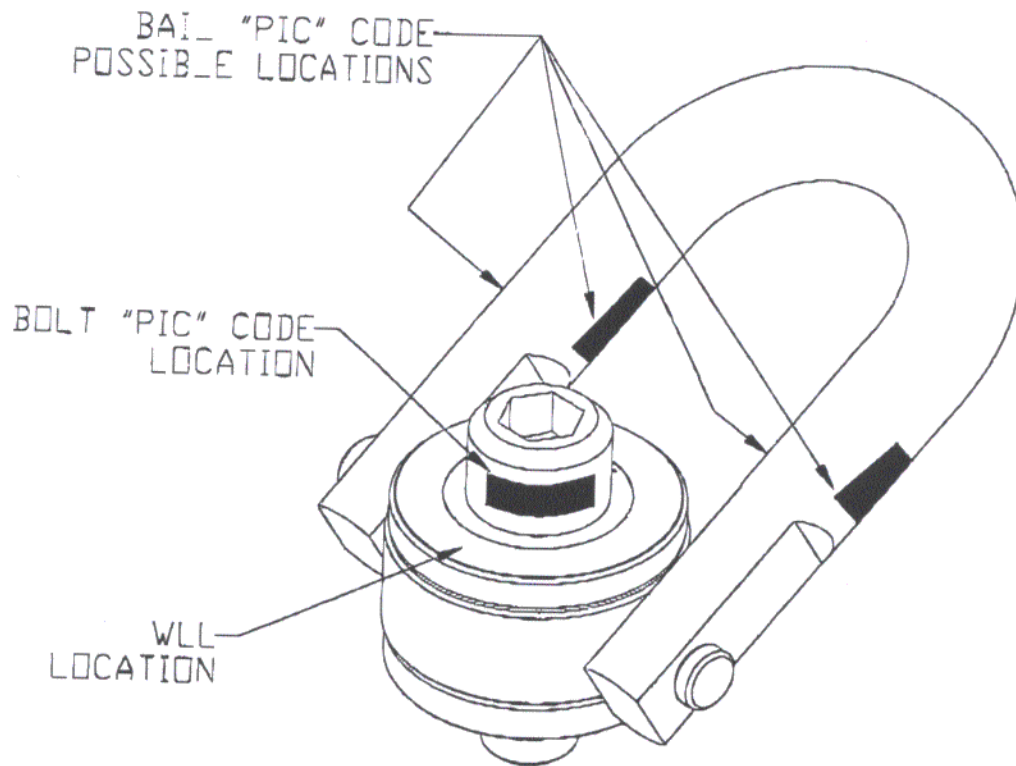
HR-125 "PIC" CODE
LOCATIONS

Owners and rigging custodians must immediately remove from service the above listed size Crosby HR-125 and HR-125M swivel hoist rings having the Product Identification Code (PIC) "Y5C" marked on the bail, or "Z7C" marked on the bolt.

Guidance Note: Refer to attached illustration for PIC code location.

Procurement staff and material requestors that procure Crosby swivel hoist rings must (1) identify if any of the above listed sizes are in inventory or in service and (2) query vendors if any of their product supplied to the Laboratory included any of the above listed Crosby swivel hoist rings.

If any of the above listed Crosby parts have been located or identified, PS-1 Institutional Quality Management, 665-5437 or 665-6377 must be contacted, by May 9, 2003. The Hoist Rings must be returned to PS-1 Institutional Quality Management Group, TA-03, SM-142. Attn: Ken Brandt
